DEPARTMENT OF TRANSPORTATION

Contract #: 04-0120F4Cty: SF/ALA Rte: 80 PM: 13.2/13.9File #: 69.28**WELDING INSPECTION REPORT****Resident Engineer:** Pursell, Gary**Address:** 333 Burma Road**City:** Oakland, CA 94607**Report No:** WIR-002022**Date Inspected:** 15-Feb-2008**Project Name:** SAS Superstructure**OSM Arrival Time:** 830**Prime Contractor:** American Bridge/Fluor Enterprises, a JV**OSM Departure Time:** 1730**Contractor:** Zhenhua Port Machinery Company, Ltd (ZPMC), Changxing Island **Location:** Shanghai, China

Bridge No: 34-0006**Component:** Tower Mock-Ups**Summary of Items Observed:**

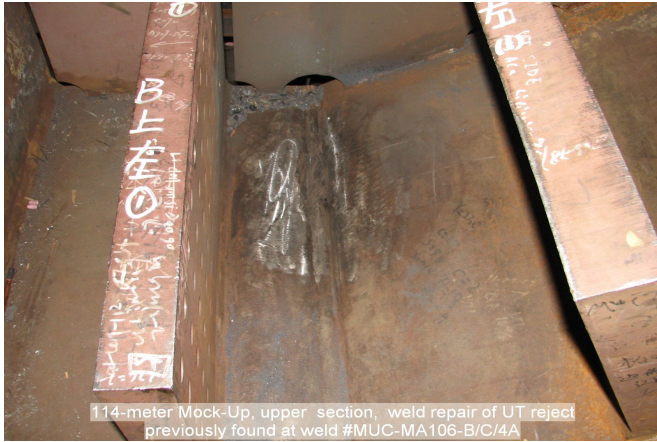
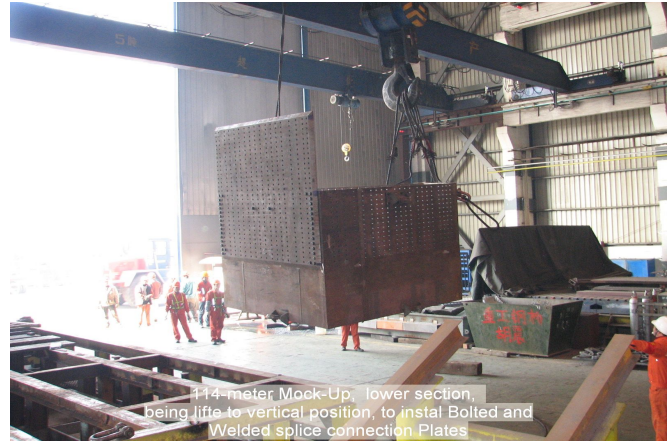
114-meter Mock-Up, upper section. Z. P. M. C. personnel attached and temporarily bolted the exterior bolted splice connection to the exterior of Skin C. After tightening of the installed bolts there is a gap on one side, between the exterior splice connection plate and Skin "C". The welded splice connection plate was then attached. The welded splice plate was aligned using bull pens. Note: the outside diameter of the bull pen is the same diameter as the interior diameter of the drilled bolt holes. This could result in the "rounding" of a section of the drilled bolt holes. When the welded splice plate is aligned and bolted in place, there is 3 millimeters (mm) of mismatch between it and the internally welded splice plate.
